When injecting samples using Fused Insert glass vials, sometimes the needle hits the insert wall, causing the insert to break. Is this due to the Inserts not being properly aligned, vertically?

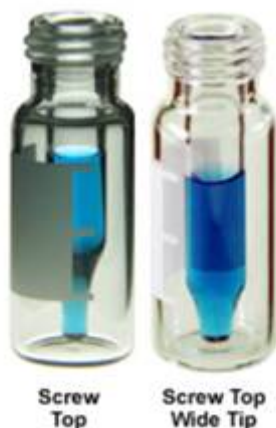
Examples of Wide Mouth Fused Insert Vials

- Too large of a needle gauge being used. If the gauge is too high, the needle may be too thin and more easily deflected and bent
- Tip style is incorrect for the septa (i.e. beveled vs. flat tip).
- Septa hardness and / or inconsistency bends or deflects the needle. Use partial slit or [Soft-Guard Brand Septa](#) in this case.
- Use wide opening vials with a Fused Insert. Here the needle is less likely to hit the side because there is more room.
