## I see a strange saw tooth type of pattern in the UV baseline using my Cogent HPLC column what is it and how can I fix it - FAQ

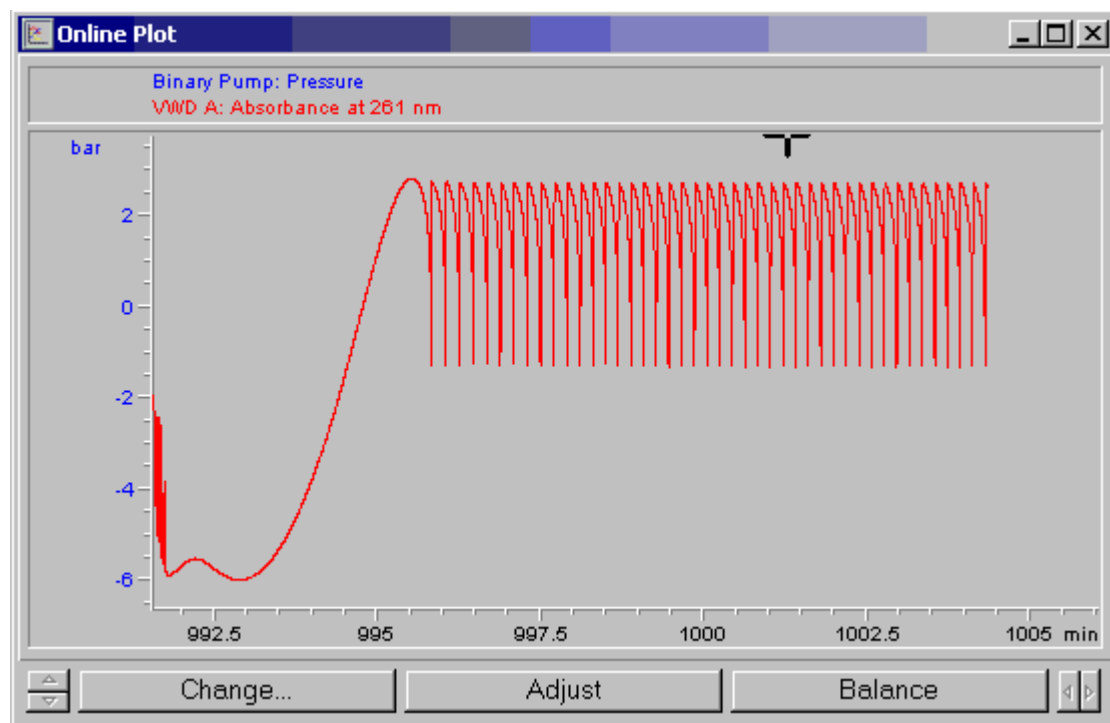
**This may be due to the presence of an immiscible solvent remaining in the column.**

Even trace amounts of these solvents can cause issues. The immiscibility manifests as an unstable baseline, such as the example shown below. In order to fix this issue, try flushing the column overnight with a mutually miscible solvent such as isopropanol to remove any immiscible non-polar solvents that may be in it.

This phenomenon can happen to Cogent TYPE-C™ columns or others columns that may have been introduced to immiscible solvents. In some cases, you might observe this with a new column if residual packing solvents may still be present.
