## Fused Insert vials that break during injection - Tips & Suggestions

**When injecting samples using Fused Insert glass vials, sometimes the needle hits the insert wall, causing the insert to break. Is this due to the Inserts not being properly aligned, vertically?**

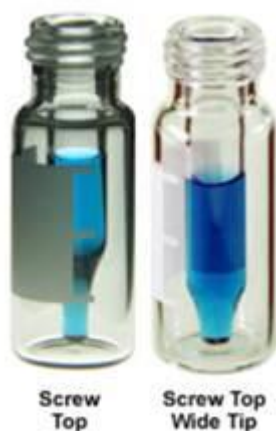
- Too large of a needle gauge being used. If the gauge is too high, the needle may be too thin and more easily deflected and bent
- Tip style is incorrect for the septa (i.e. beveled vs. flat tip).
- Septa hardness and / or inconsistency bends or deflects the needle. Use partial slit or [Soft-Guard Brand Septa](#) in this case.
- Use wide opening vials with a Fused Insert. Here the needle is less likely to hit the side because there is more room.

*Examples of Wide Mouth Fused Insert Vials*
